Step 3: Current Conditions

Soil Resources

Current Conditions - Erosion Processes

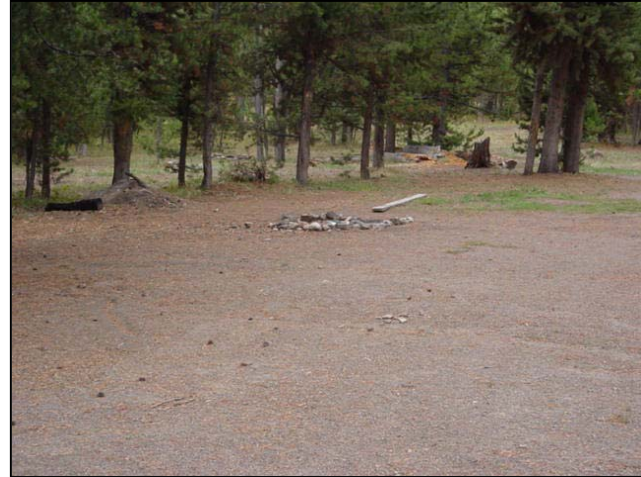
Currently, recreation activities, recent disturbances from timber harvest activities and continued development of privately-owned lands in the watershed have had the most adverse impact on the soil resource. The proliferation of pioneered trails created by off-highway vehicles (OHV) is causing soils to erode at an accelerated rate on the uplands where they occur. Camping and recreation use along the riparian areas have compacted soils and impacted stream banks in some areas. Soil compaction and erosion from recreational use has been well documented (Meeuwig et al., 1975). Figure 7 shows soil compaction around a camping site near Island Park Reservoir at Mill Creek where soils have lost productivity potential due to compaction and trampling.

Figure 7 Soil compaction from dispersed camping.

Approximately 100 acres have been adversely affected by recreation use in the watershed. Because of the extent and amount of disturbance related to recreation use, a complete inventory of restoration needs should be documented and a plan developed for scheduled restoration work.

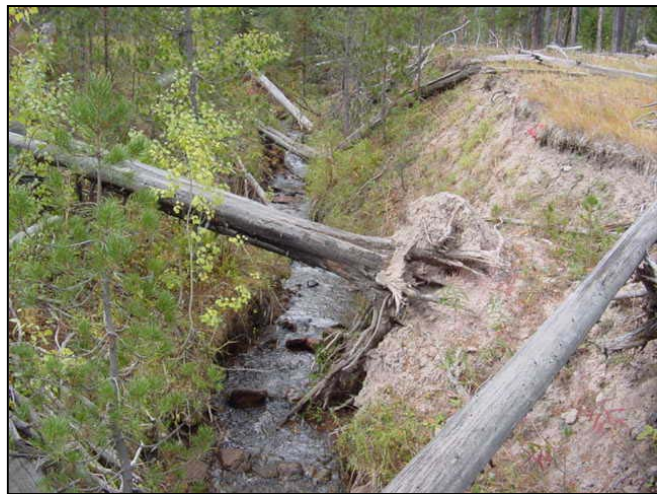
Areas of contour furrowing have been completed on Sawtell Peak to control erosion. Several streams have been diverted in the past causing the channels to down-cut and erode. Some areas are eroded as much as 8 feet down (Figure 8). Slope also has a strong influence on erosion. Most of the slopes in the Blue Creek watershed are less than 40%. The WEPP (Water Erosion Prediction Program) model shows little or no erosion occurring on slopes with less than 40% when ground cover is maintained at 60%. Table 10 shows acres of each slope break in the watershed. Data from the Upper Snake River Erosion Report (USDA 1979) show forested lands in Fremont County eroding less than 0.1 tons per acre per year.

Figure 8 Down-cutting in the stream channel.

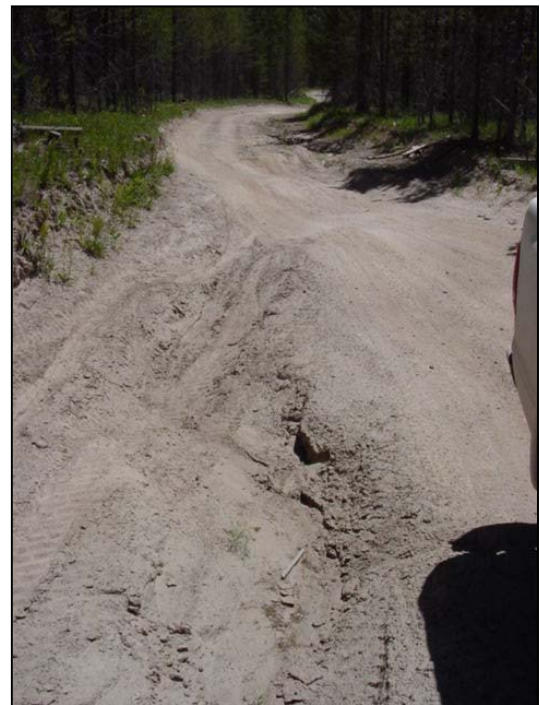
**Figure 9 Erosion occurring on Forest Road 455.**

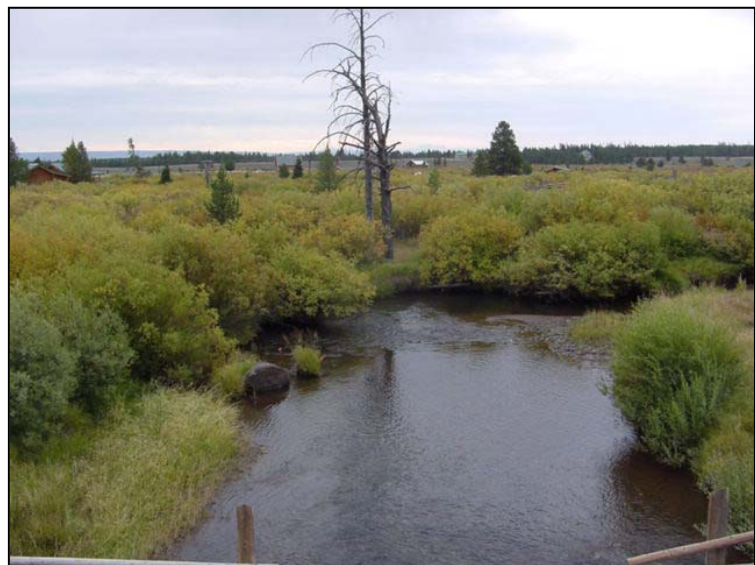
Figure 11 Hotel Creek on private lands in the Blue Creek Watershed.

Some private holdings have recently been developed on the south and east portions of the watershed taking land out of production. These housing developments usually occur near streams and lakes in the watershed. Figure 11 is an example of housing developments on Hotel Creek. This trend is likely to continue in the future.

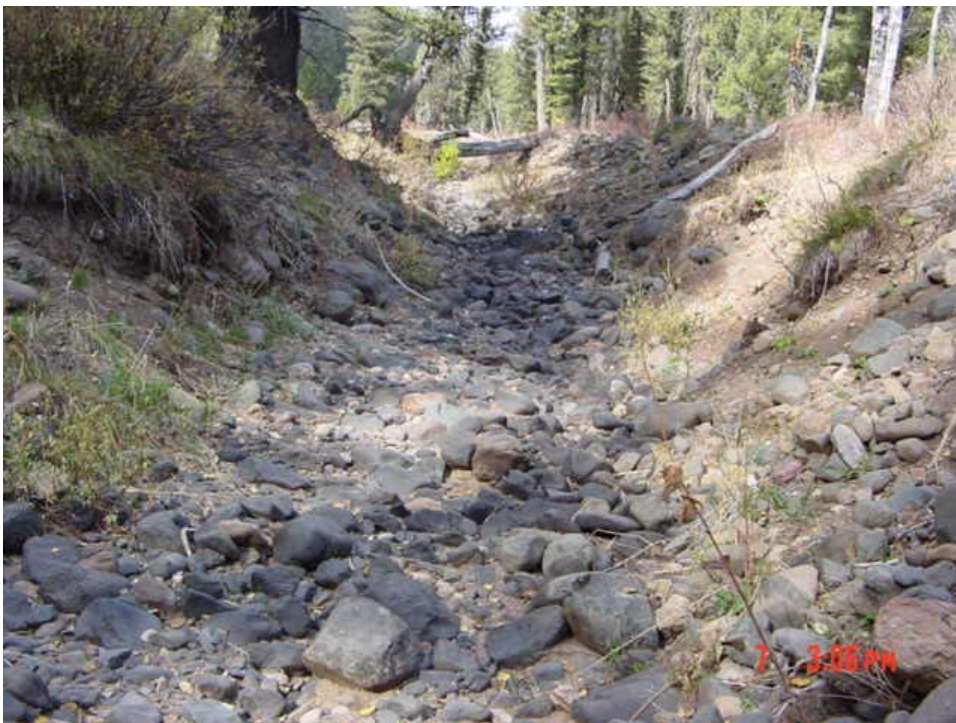
Figure 14 A typical reach of Blue Creek in section 27, Township 14 North, Range 42 East.

Much of Blue Creek has downcut several feet. One reach has downcut as much as 10 feet.

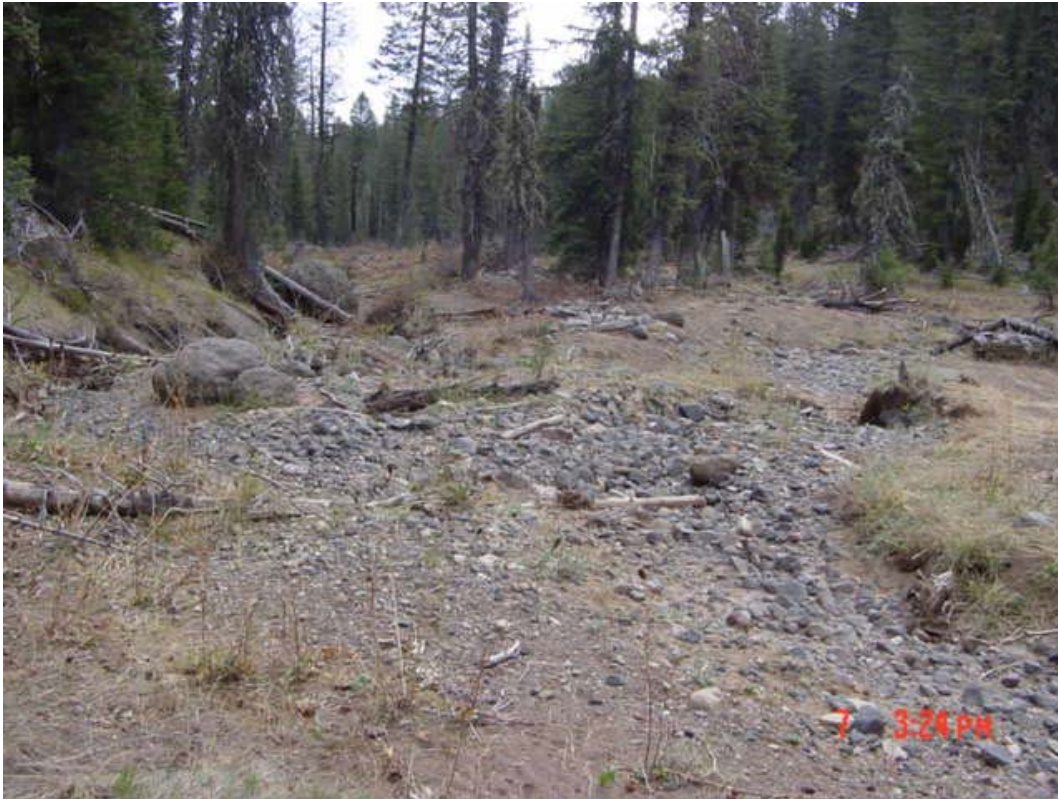
Figure 15 Despite the dry nature of the channel, the bed material is extremely mobile when flows occur. A deposition area caused the channel to split, which moved tons of material.

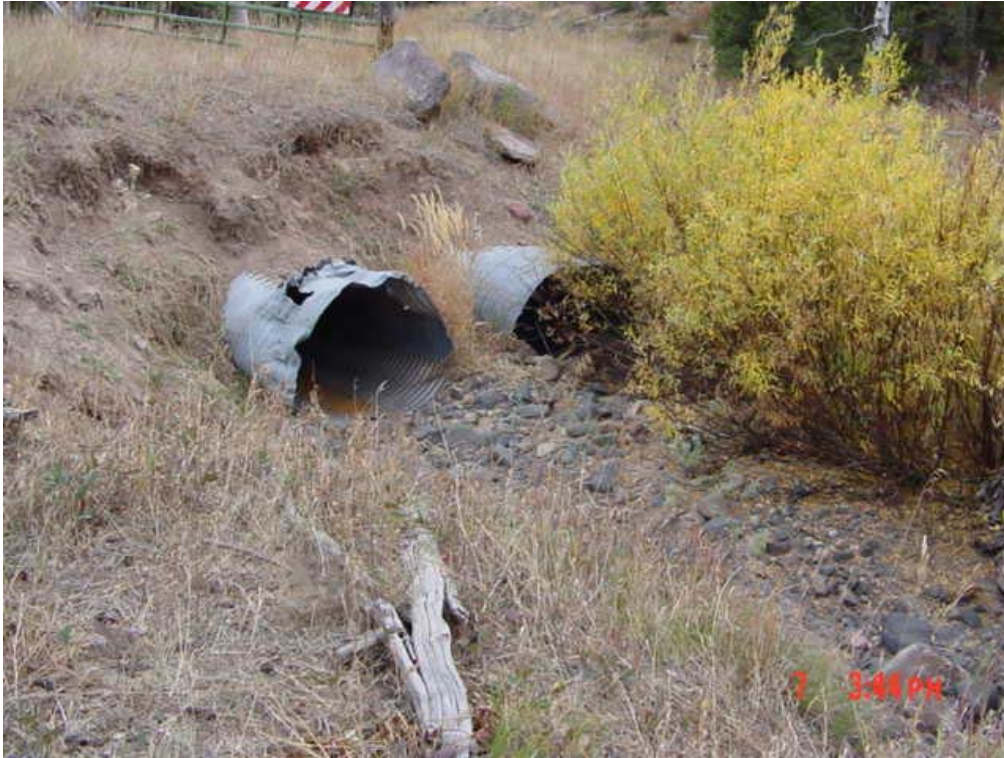
Figure 18 Twin culverts at FDR 018. The road has been closed but the culverts remain.

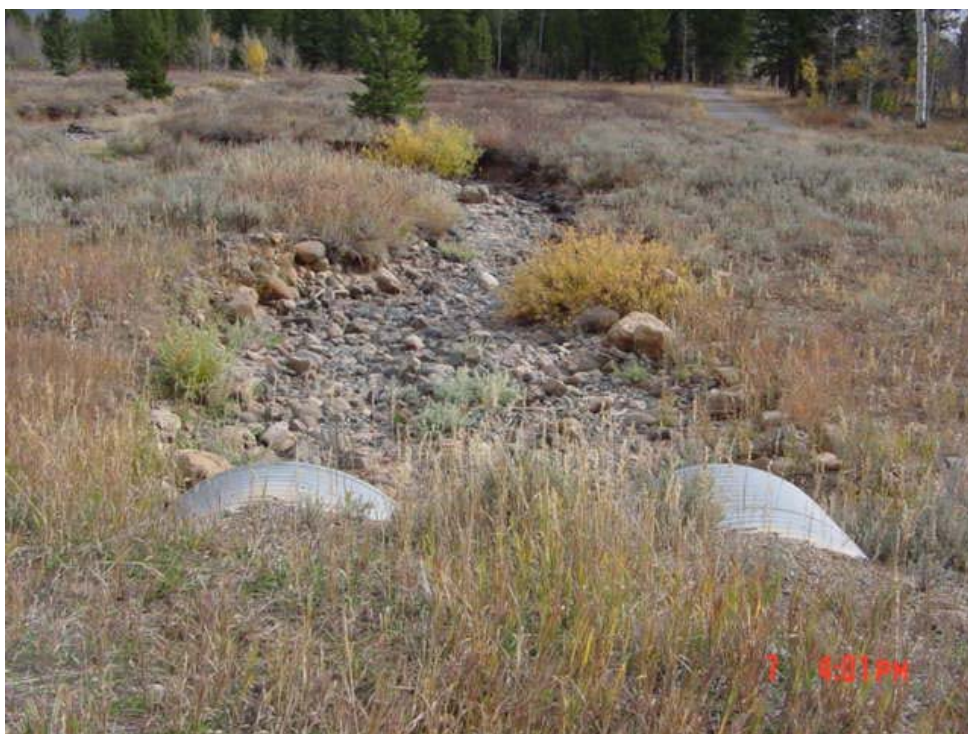
Figure 20 Twin culverts on the Yale-Kilgore road (030). The culverts are about 1/3 buried by bedload cobble and gravels.

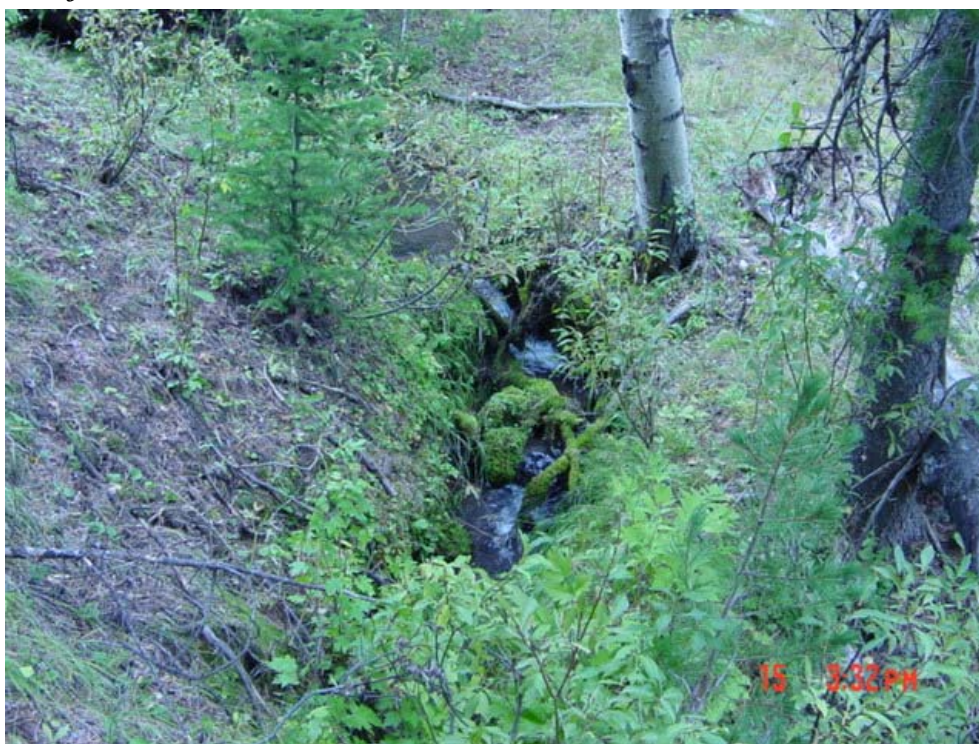
Figure 21 Bootjack Creek

Upper Bootjack Creek is a relative pristine stream, but is downcut 1 to 2 feet. The channel type is G4, with intermittent 1 foot high headcuts regulated by root wads and woody debris. Bankfull width is about 3 feet. Bankfull depth is about 0.5 feet. Flow is about $\frac{1}{4}$ cfs.

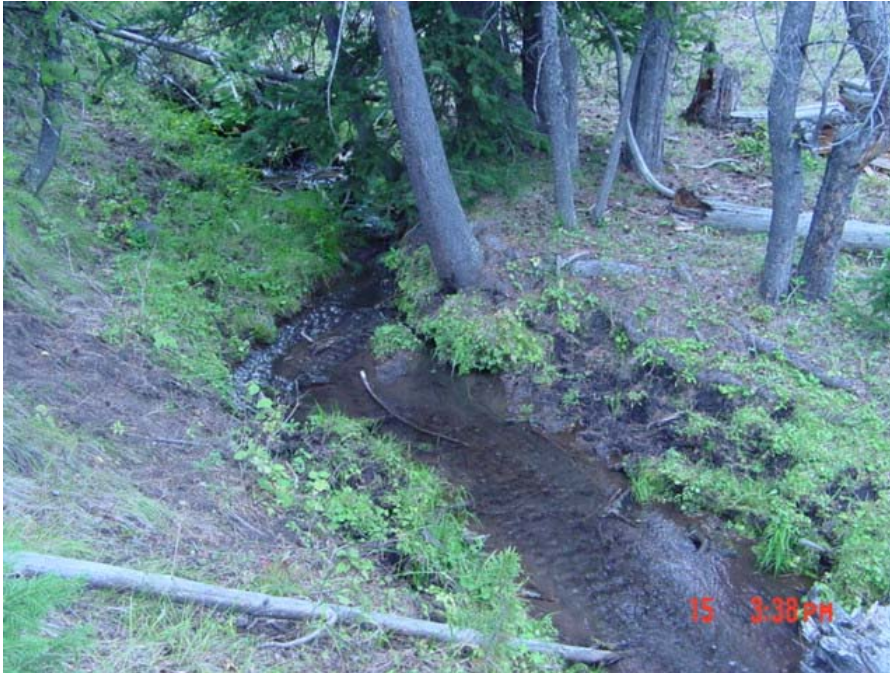
Figure 22 Where livestock can access the stream, the banks have been trampled and the stream is widening.

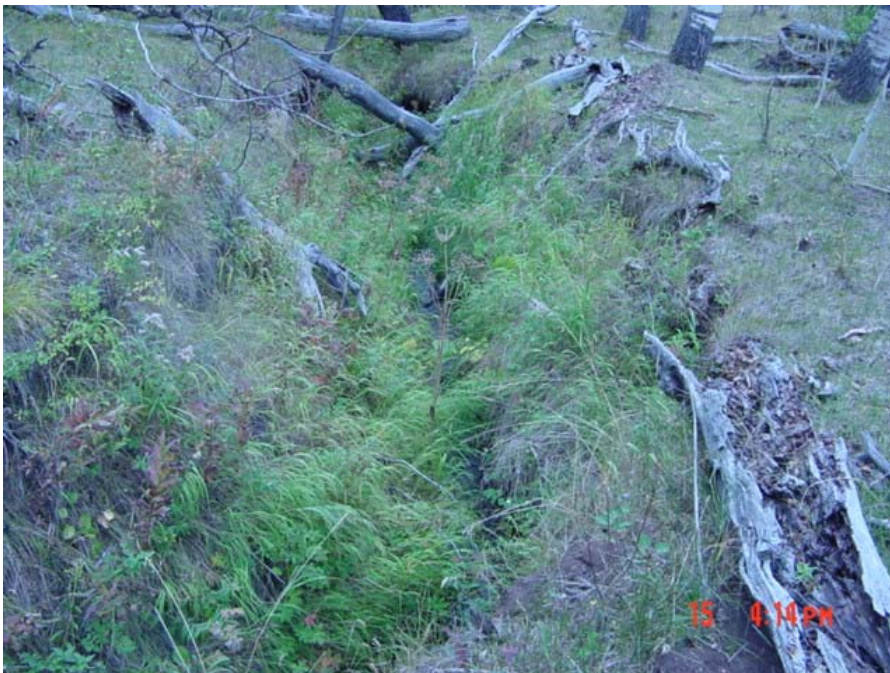
Figure 23 Much of Bootjack Creek has downcut, in some places as much as 6 feet or more.

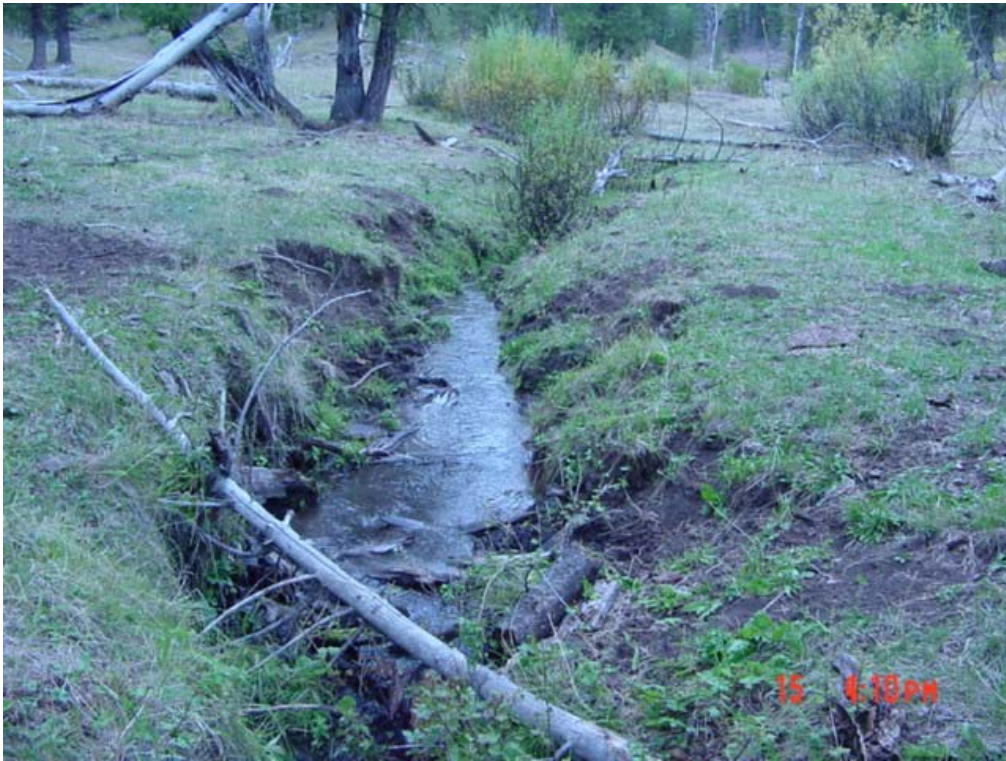
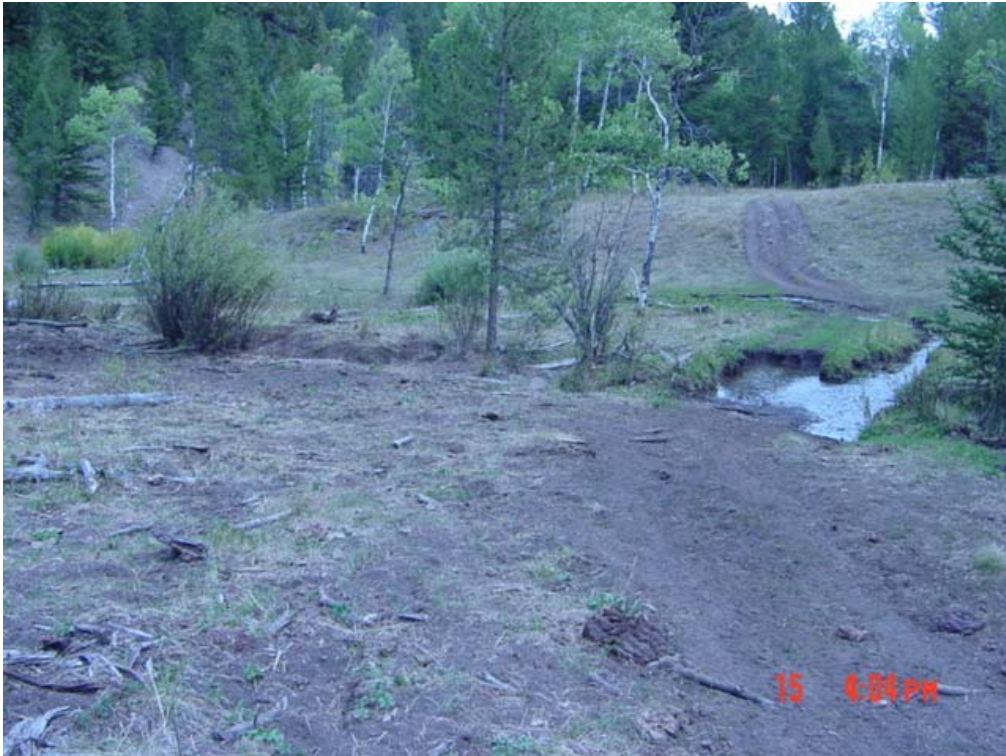
Figure 24 Both livestock and ORVs have had an impacts on the stream and riparian areas.

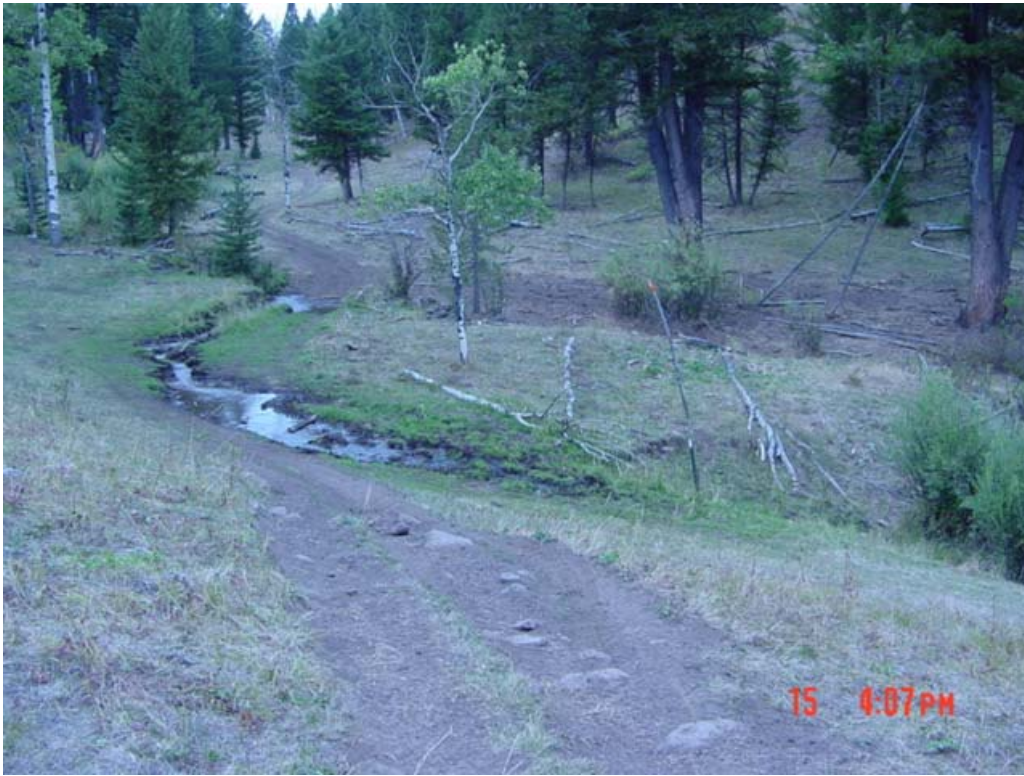
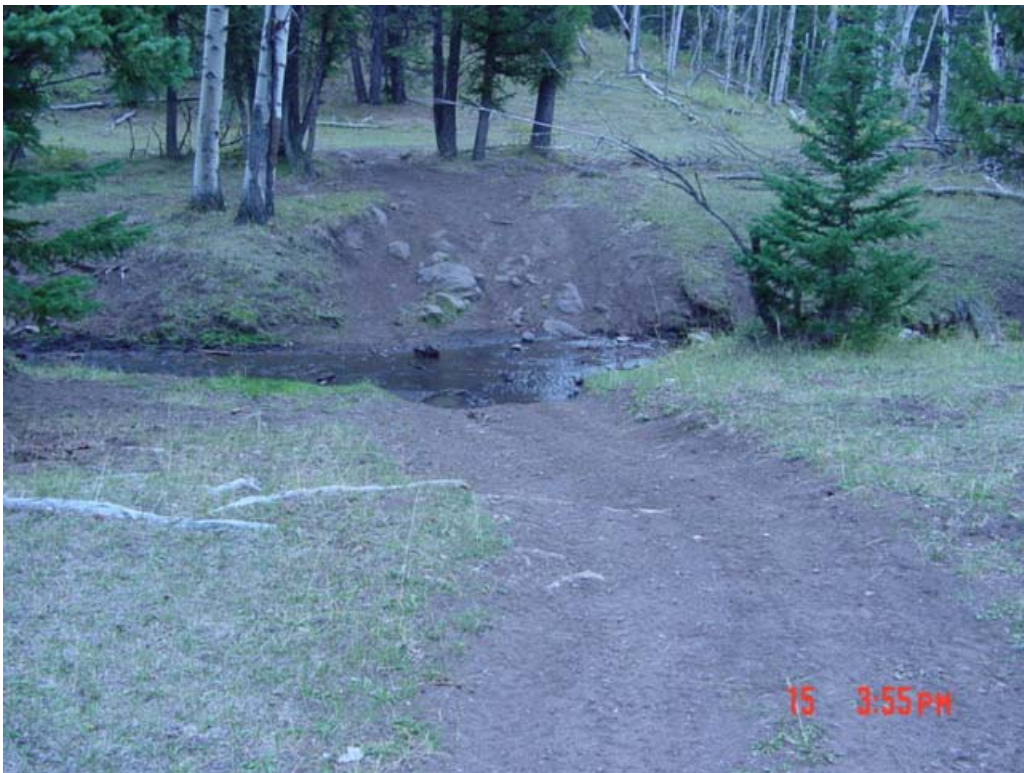
Figure 25 Another ORV crossing site.

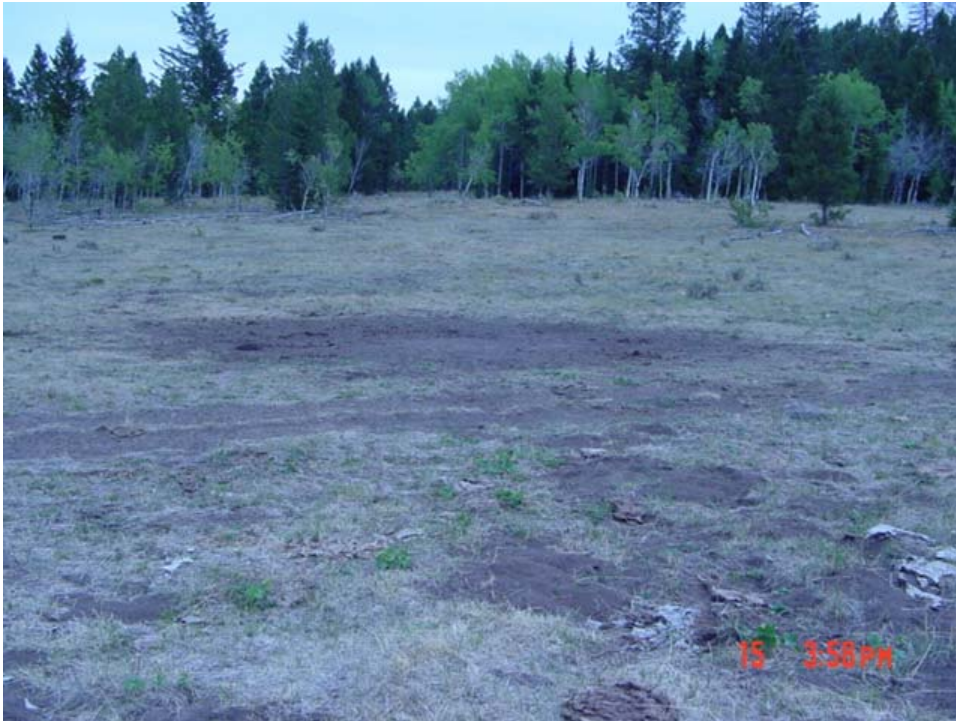
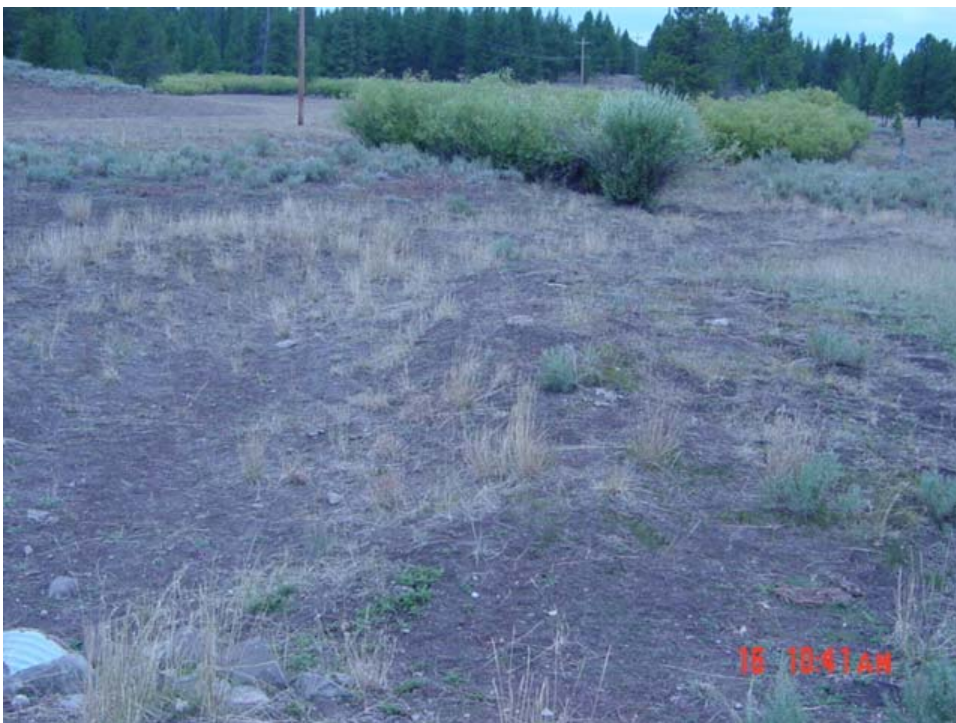
Figure 26 Salt has been placed in this riparian meadow, adjacent to the stream.

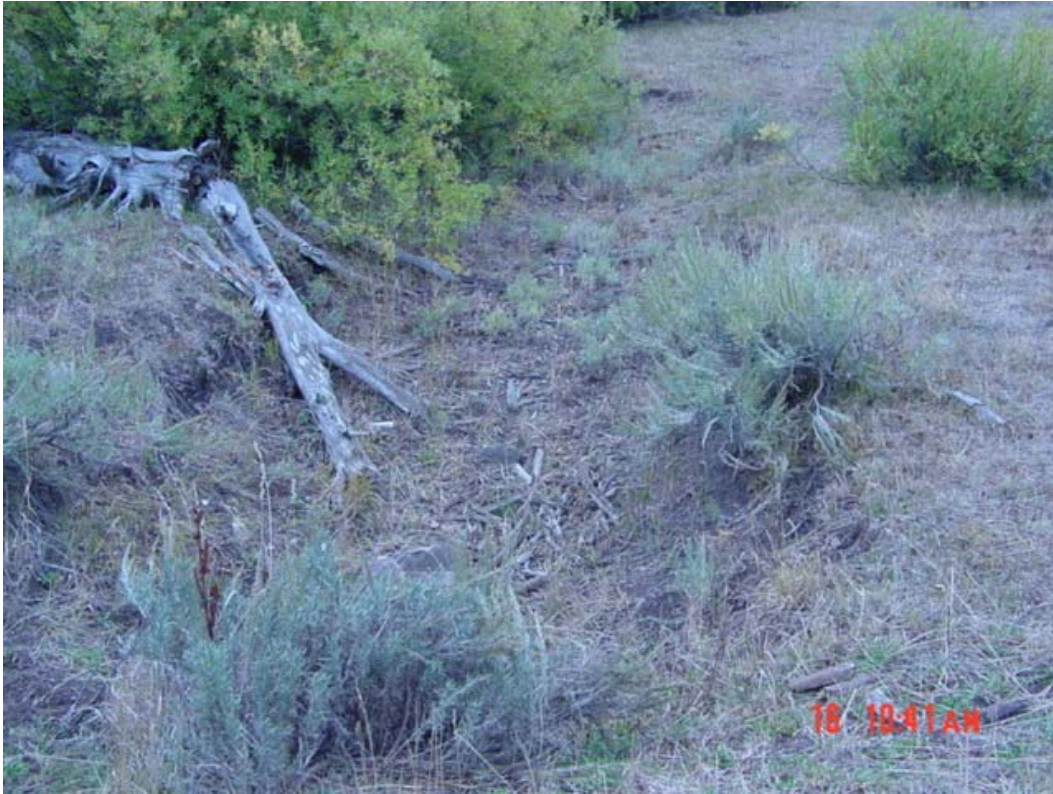
Figure 27 The surface flow stops where the valley widens adjacent to FDR 053. Some willows are growing in the channel, but other riparian vegetation is not present. Heavy use by livestock is evident here as well.

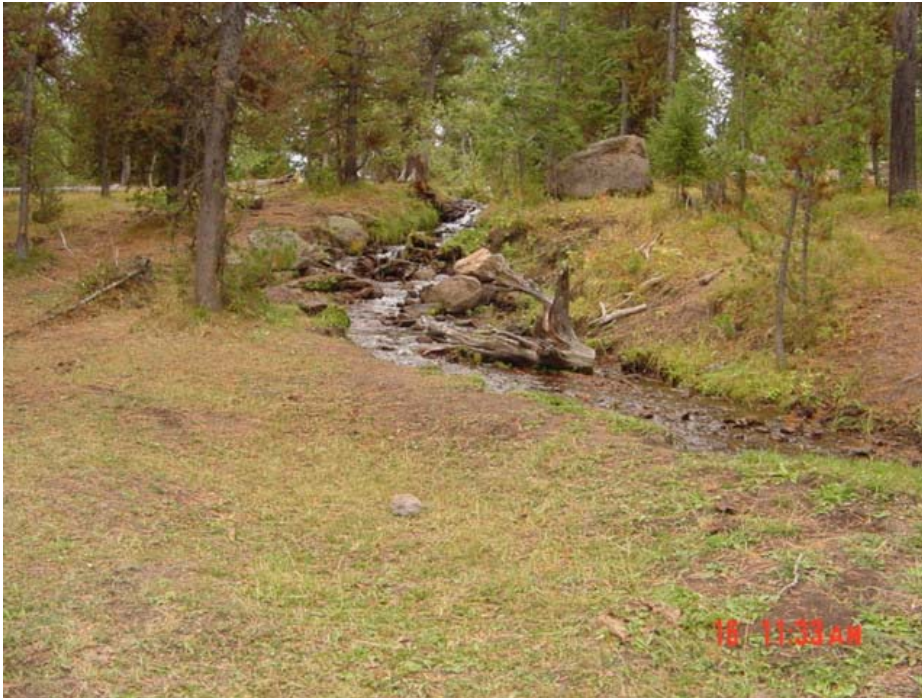
Figure 39 About ½ mile above FDR 455 the stream drops off a bench. It appears as the stream has been diverted to take this route.

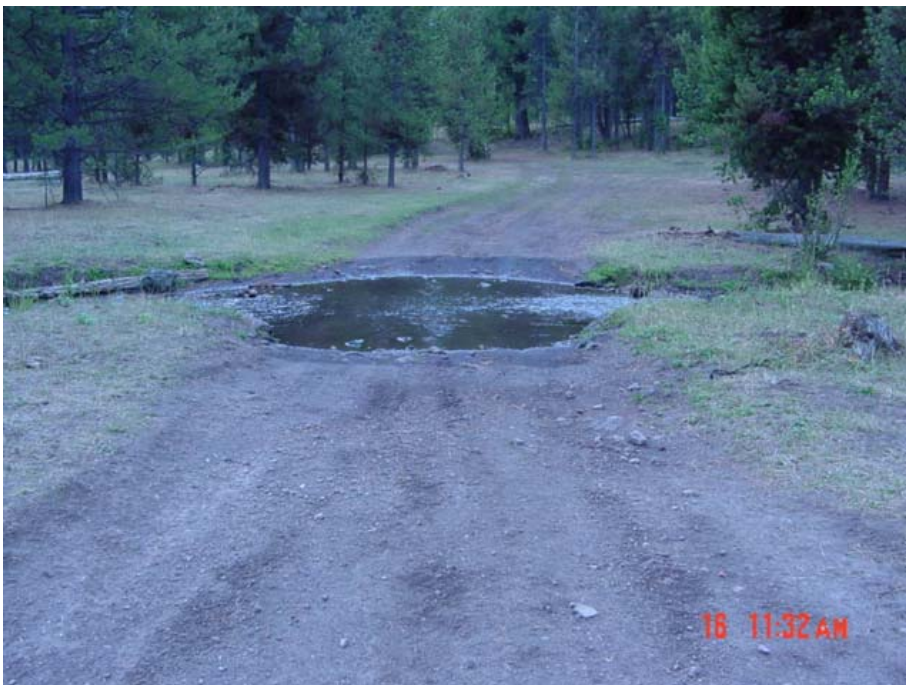
Figure 40 About ¼ mile below the above picture, the stream is channelized and is heavily impacted by dispersed campers and livestock. This is an ORV crossing site that just goes to a dispersed camping site on the other side of the stream.

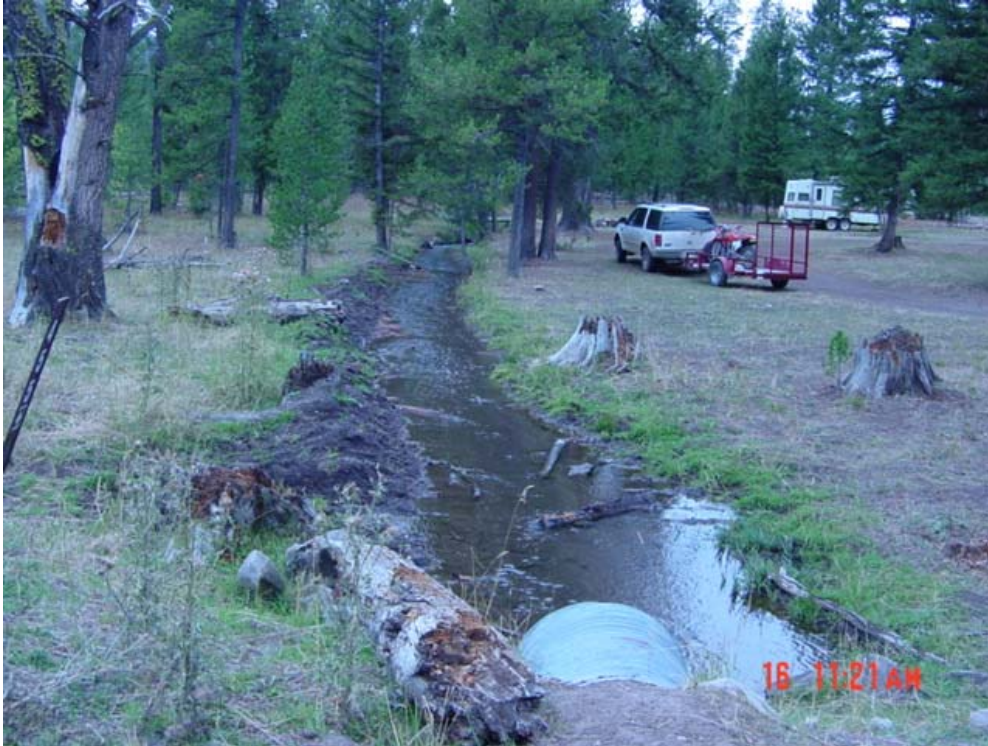
Figure 41 “North” Sawtell Creek at the FDR 455 crossing looking upstream. The area is heavily utilized by campers and ORVs. The channel appears to have been recently dredged.

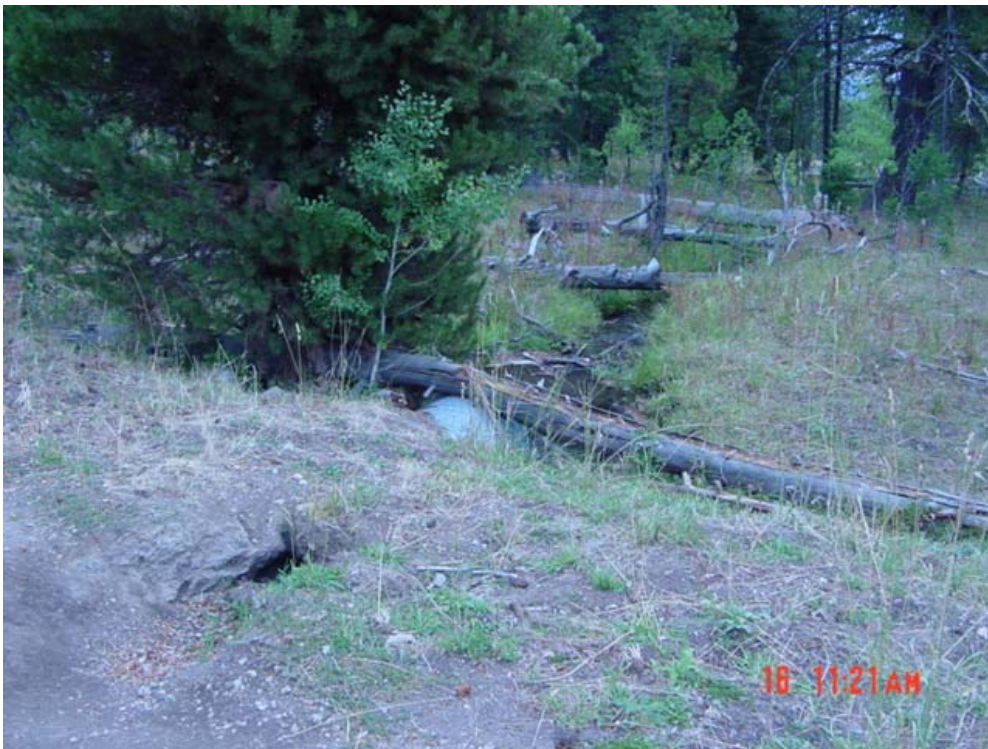
Figure 42 “North” Sawtell Creek at FDR 455, looking downstream. The stream is channelized down to private lands below.

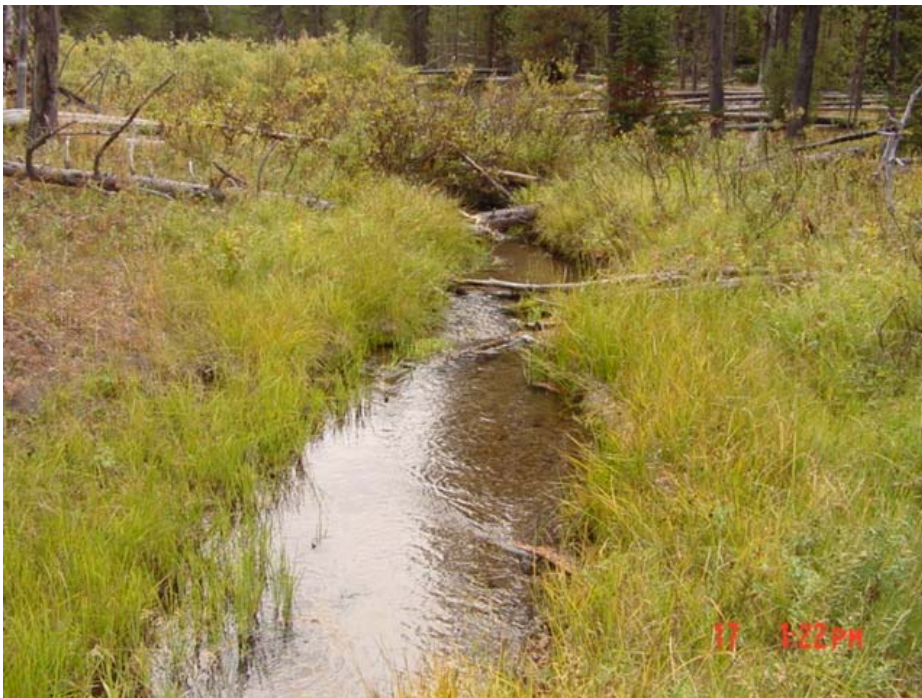
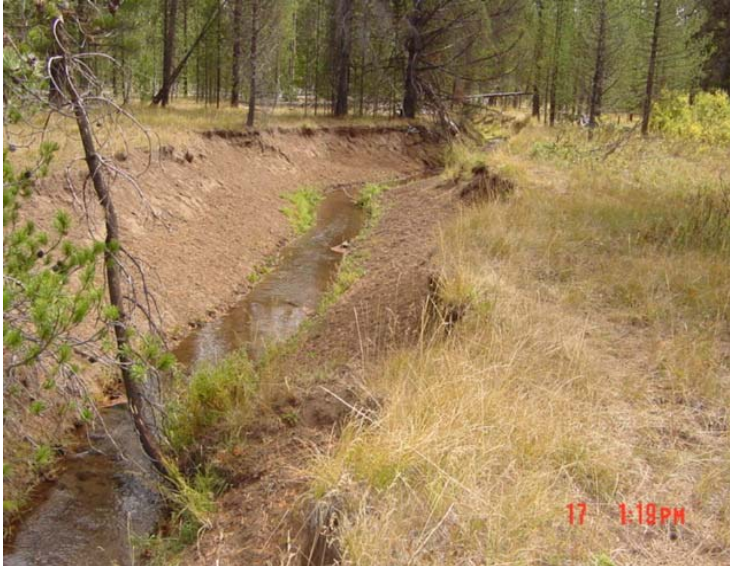
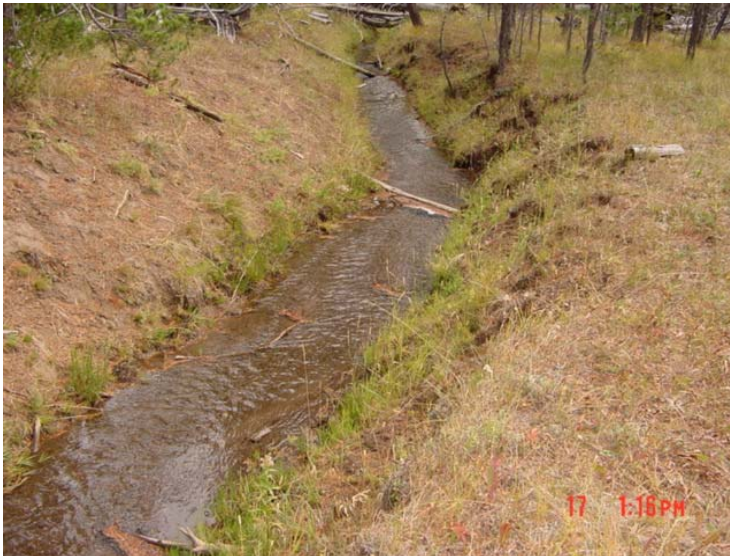
Figure 44 Diversion channel on South Sawtell Creek.

Several decades ago, the channel was diverted to a small pond. The diversion channel has downcut 6' to 8' over the years.

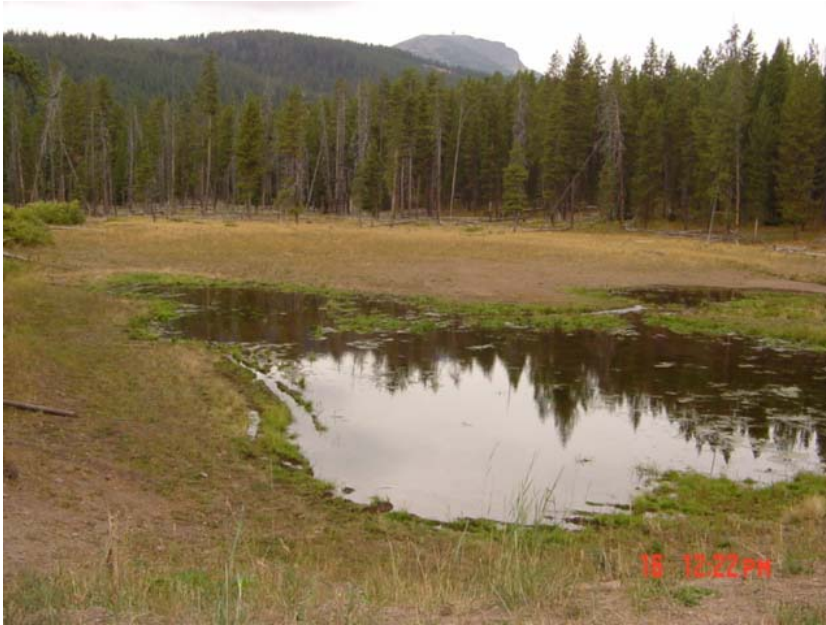
Figure 47 Small pond diversion on South Sawtell Creek

The pond holds some water during the spring runoff, but dries to a small puddle during the summer. A proposal has been made to repair the facility and restore the reservoir for fisheries. The original channel is to the left of the photo where the willows are growing. Below this pond, the stream is partially channelized for downstream irrigation on private land.

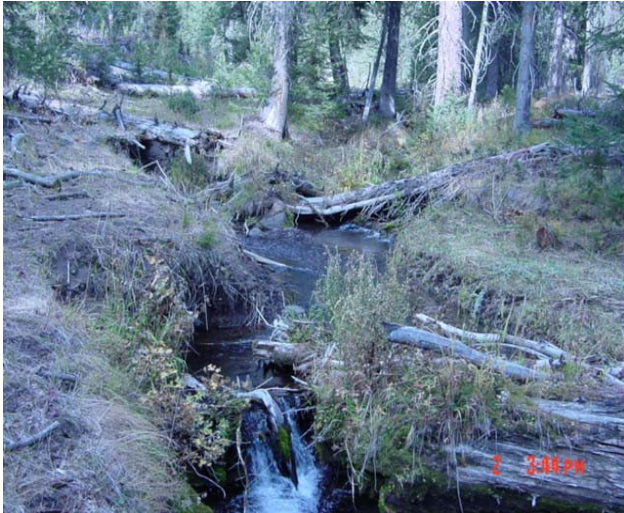
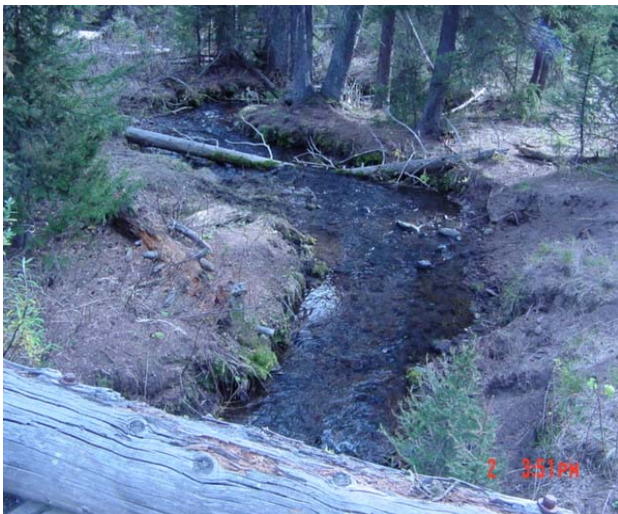
Figure 58 Sheep watering sites.

(Figure 58, Figure 59) These sites have been used regularly over the past several years. The banks have been sheered and riparian vegetation has been consumed and or trampled. This site represents less than 1% of the stream.

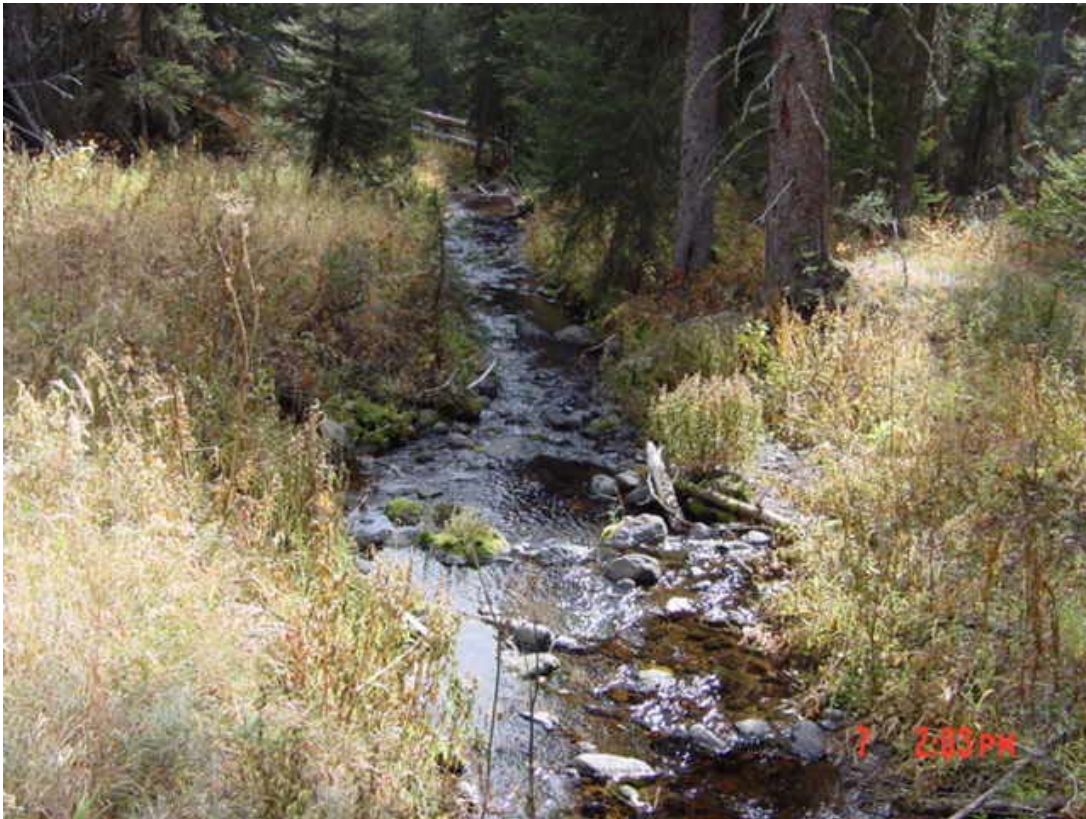
Figure 62 West Fork Hotel Creek

A typical reach of West Fork Hotel Creek is shown in Figure 62. This is a B3 channel type, with an excellent riparian area. However, sand has embedded the cobble up to 50% in some riffles and nearly 100% in some pools. In the center of the photo, there is a small lateral channel scour caused by woody debris.

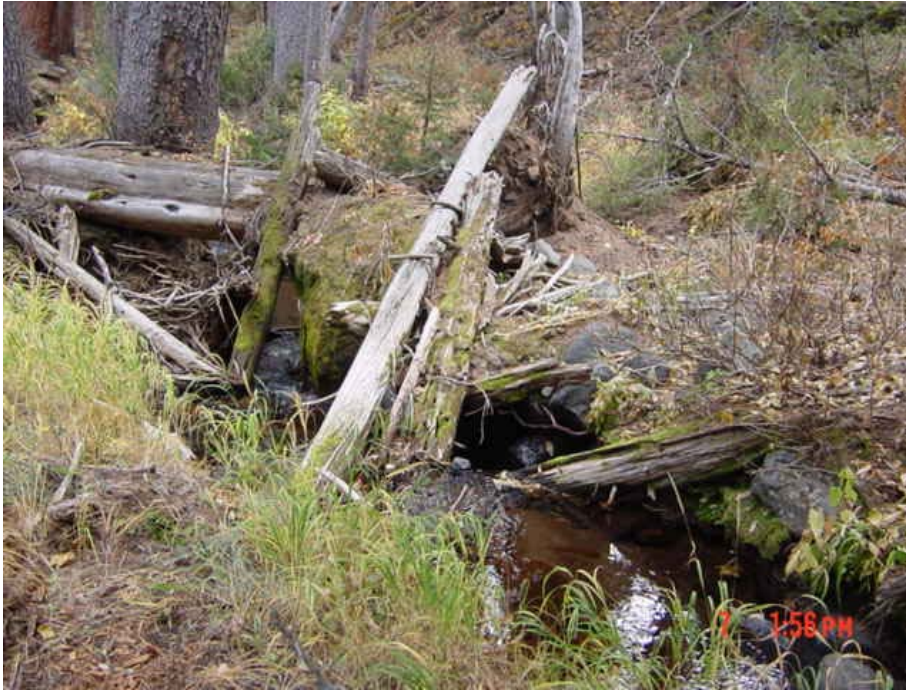
Figure 63 West Fork Hotel Creek about 1.5 miles above the FDR 048 crossing.

Debris jams have created a small scour channel that carries water during higher flows (Figure 63). Sands and gravels have accumulated behind the debris. Flow is about 0.5 cfs.

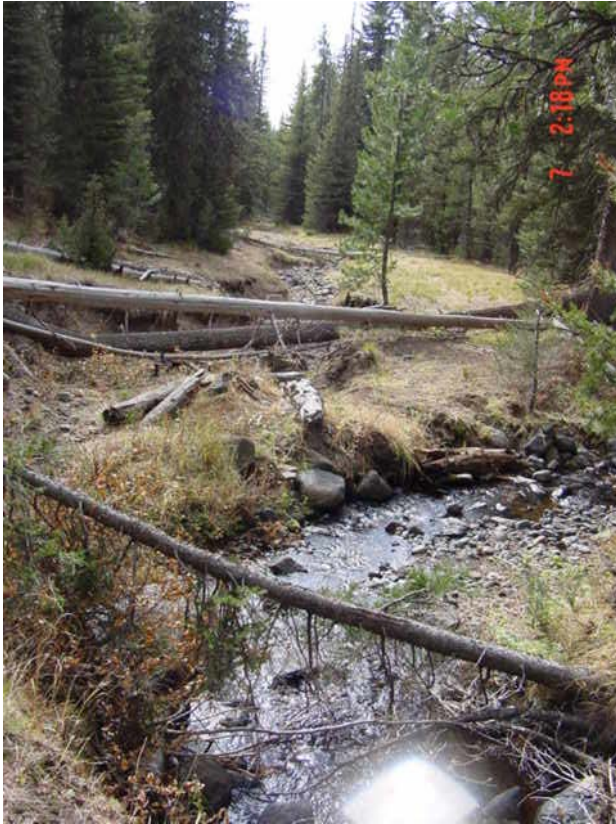
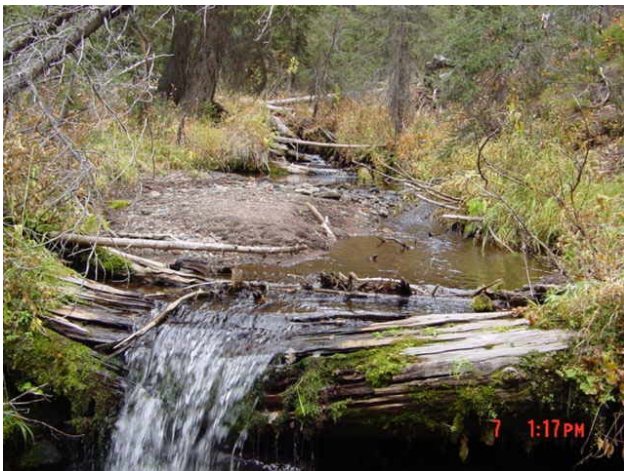
Figure 65 West Fork approximately ¼ mile above the FDR 048 crossing, debris jams have captured large amounts of fines, particularly sand.

West Fork approximately ¼ mile above the FDR 048 crossing, debris jams have captured large amounts of fines, particularly sand. The large sand bar on the left side of the right photo is unstable and moves during higher flows. The cause is thought to be an abandoned road paralleling the stream. The road is probably associated with an old timber sale located in the upper portions of the watershed.

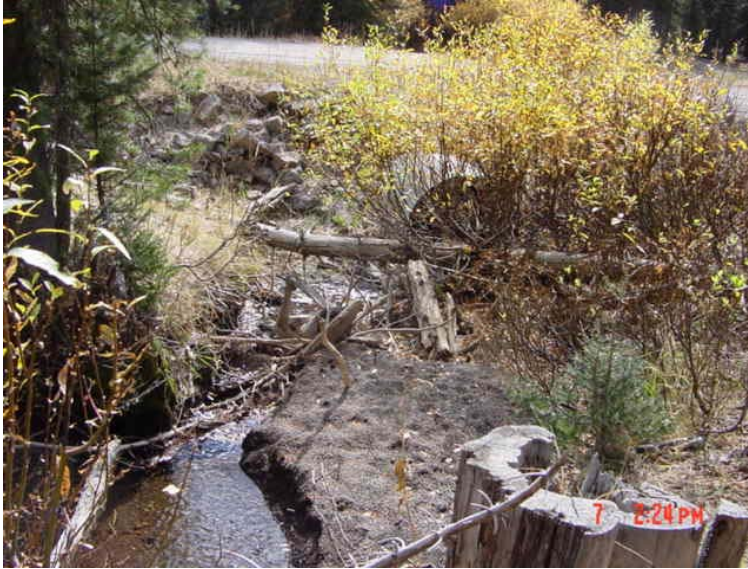
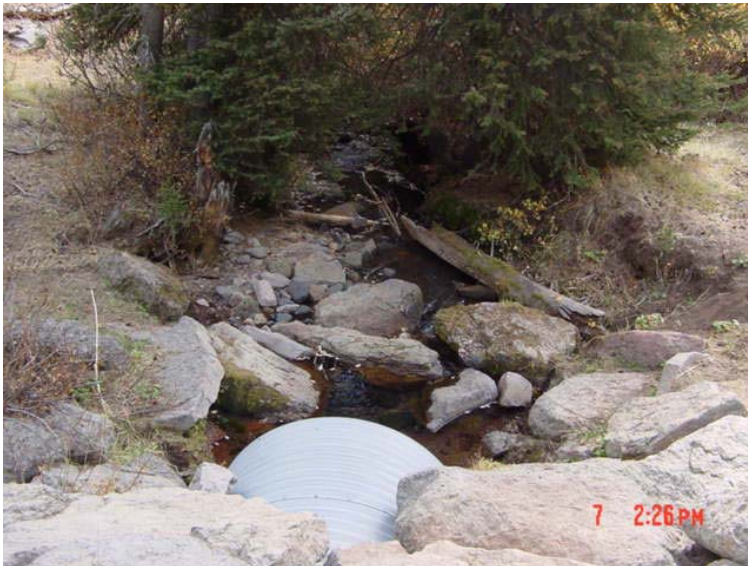
Figure 67 Culvert inlet at the FDR 048 crossing.

Figure 68 Culvert outlet at the FDR 048 crossing.

Note the large sand bar on the right side of the left photo. The outlet area is relatively clean of gravel, probably because of the higher velocities generated through the culvert during higher flow periods (Figure 67, Figure 68).

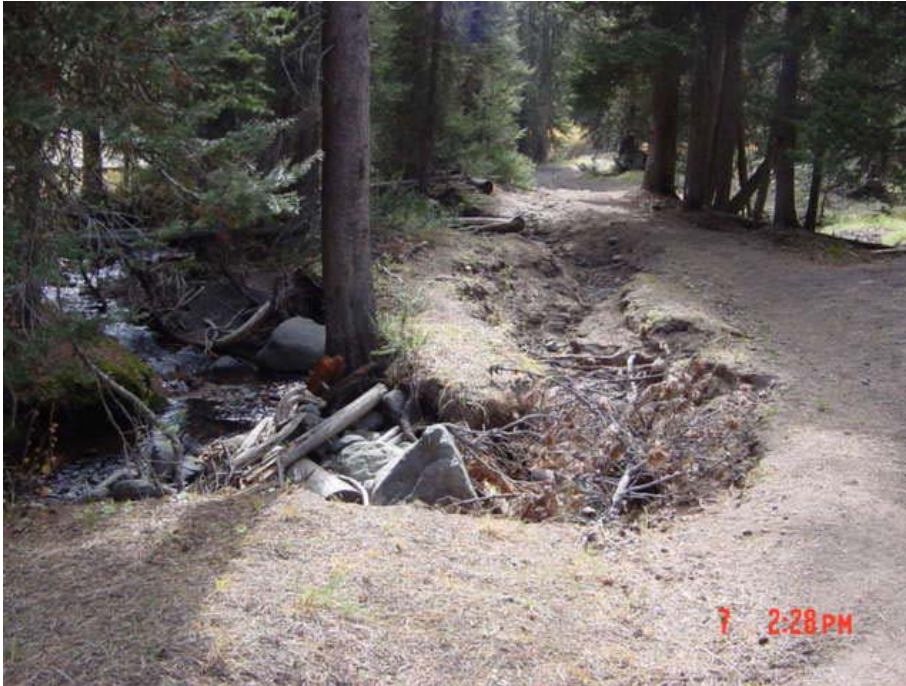
Figure 69 Downstream of the FDR 048 crossing

Just downstream of the FDR 048 crossing (Figure 69), an old access road parallels the channel. At this point the stream was intercepted by the road and streamflows scoured a parallel channel. An attempt was apparently made to plug the diversion, but it appears to be ineffective at high flows. Most of the scoured material has been deposited into the stream.
